Kasson Flood Relief Improvements

Latest Flooding - 2019 – State Disaster Declaration

Solution and Bonding Bill Request

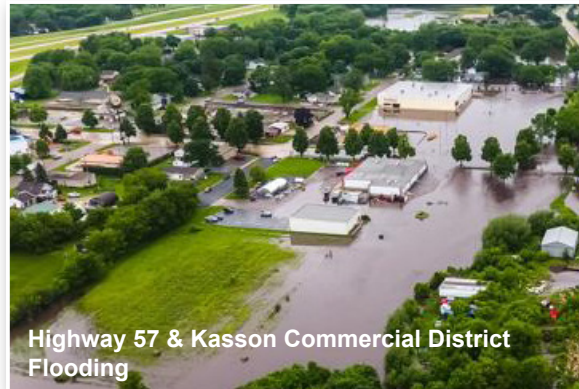
Highway 57 & Kasson Commercial District Flooding

- » 160 properties reported flooding/ sewer backups/water in basements
- » Highway 14, Highway 57 and County Road 34 closed due to flooding
- » City sanitary sewer infrastructure was damaged, causing backups in homes and discharge of raw sewage to Public Waters.

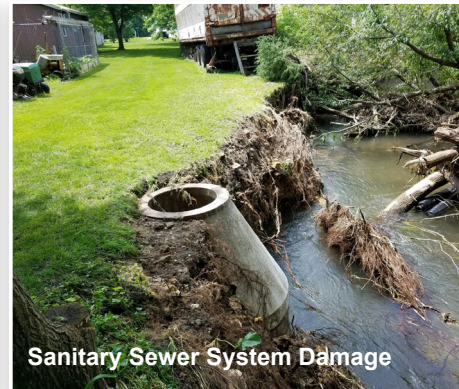
Sanitary Sewer System Damage

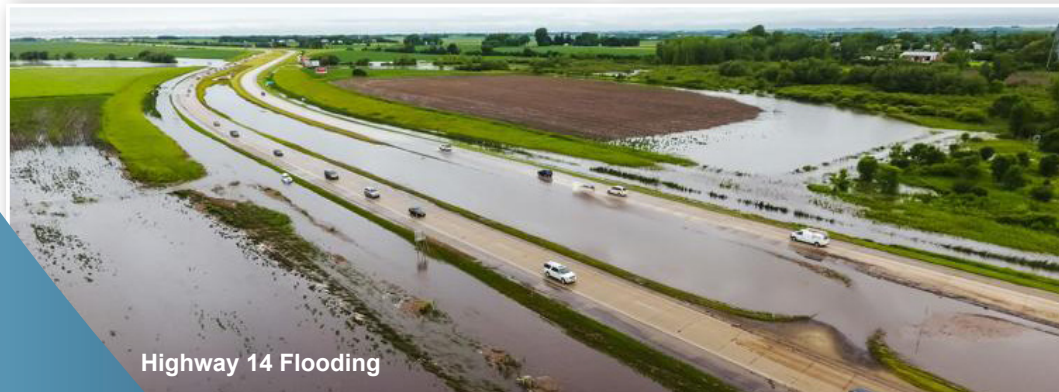
Highway 14 Flooding

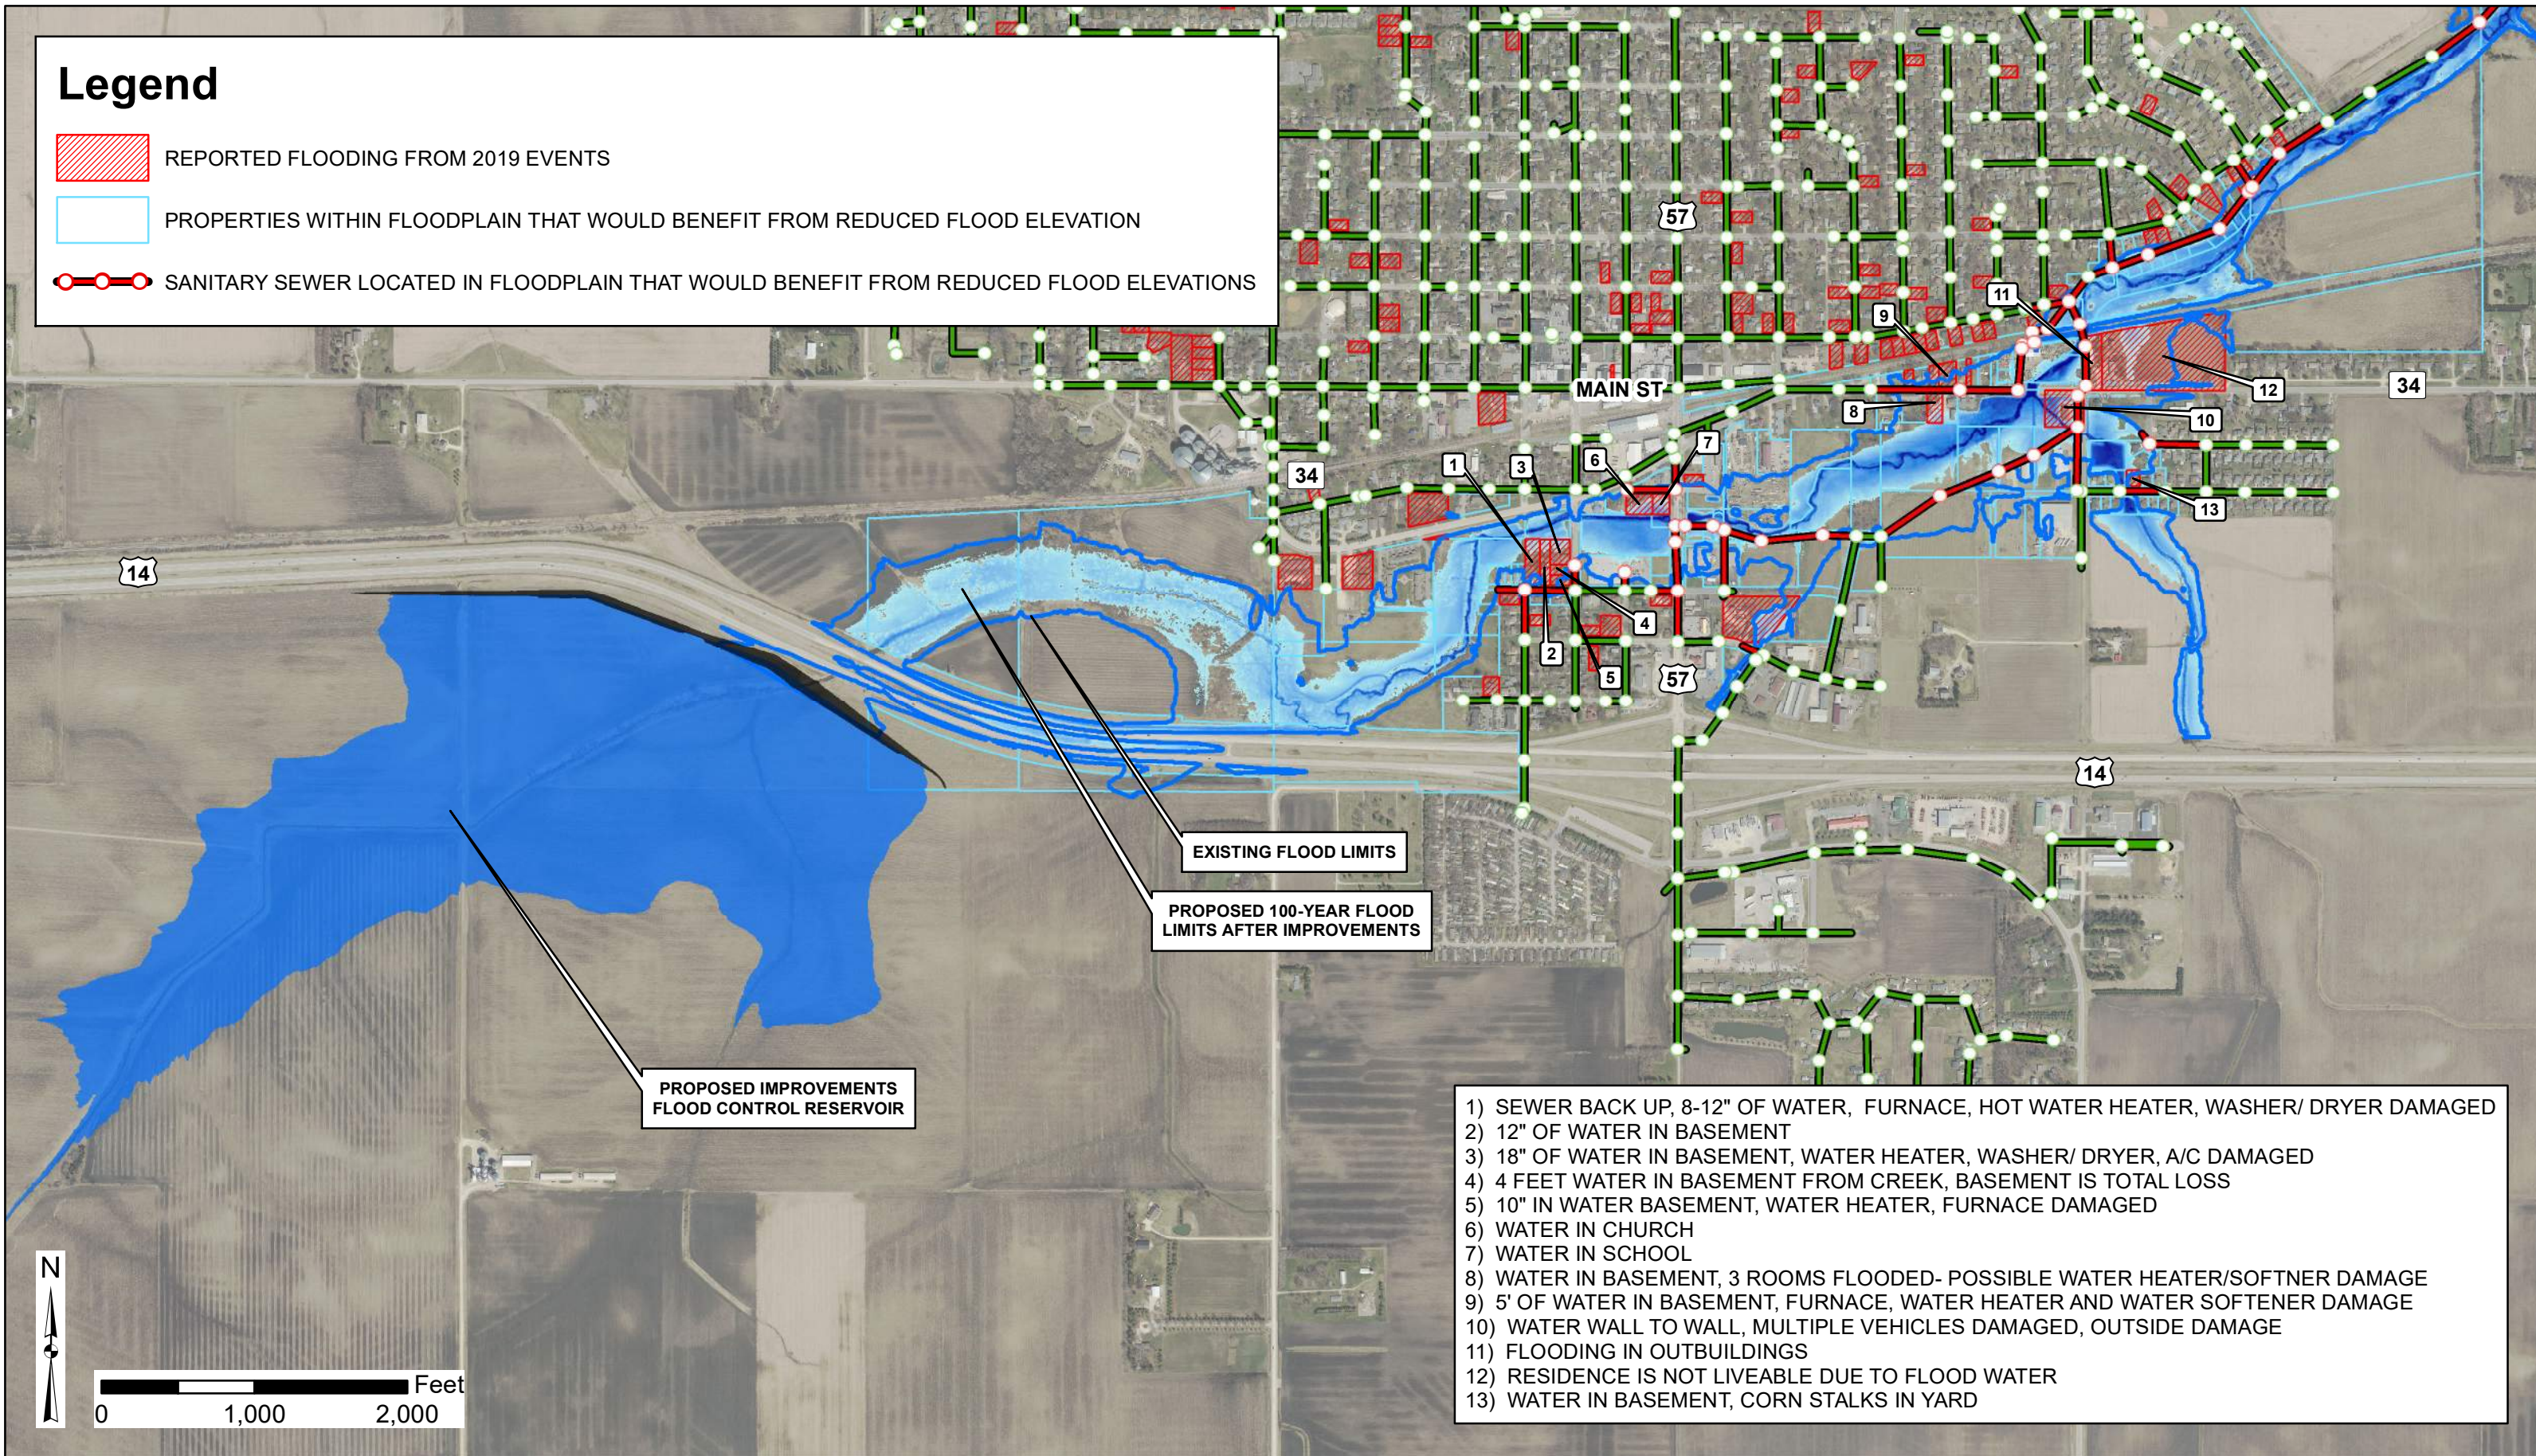
REPORTED FLOODING FROM 2019 EVENTS
-

PROPERTIES WITHIN FLOODPLAIN THAT WOULD BENEFIT FROM REDUCED FLOOD ELEVATION
-

SANITARY SEWER LOCATED IN FLOODPLAIN THAT WOULD BENEFIT FROM REDUCED FLOOD ELEVATIONS

- 1) SEWER BACK UP, 8-12" OF WATER, FURNACE, HOT WATER HEATER, WASHER/ DRYER DAMAGED
- 2) 12" OF WATER IN BASEMENT
- 3) 18" OF WATER IN BASEMENT, WATER HEATER, WASHER/ DRYER, A/C DAMAGED
- 4) 4 FEET WATER IN BASEMENT FROM CREEK, BASEMENT IS TOTAL LOSS
- 5) 10" IN WATER BASEMENT, WATER HEATER, FURNACE DAMAGED
- 6) WATER IN CHURCH
- 7) WATER IN SCHOOL
- 8) WATER IN BASEMENT, 3 ROOMS FLOODED- POSSIBLE WATER HEATER/SOFTNER DAMAGE
- 9) 5' OF WATER IN BASEMENT, FURNACE, WATER HEATER AND WATER SOFTENER DAMAGE
- 10) WATER WALL TO WALL, MULTIPLE VEHICLES DAMAGED, OUTSIDE DAMAGE
- 11) FLOODING IN OUTBUILDINGS
- 12) RESIDENCE IS NOT LIVEABLE DUE TO FLOOD WATER
- 13) WATER IN BASEMENT, CORN STALKS IN YARD
